Faisal Khan, Ph.D., P.Eng.

I. INTRODUCTION

On February 28, 2023, Tuesday, at 11:21 p.m., near the settlement of Evangelismos Tempon, Larissa, the electric passenger train INTERCITY (IC) 62, which was running a scheduled route on the route Athens - Thessaloniki, collided head-on with commercial train 63503, which was running the route Thessaloniki - Athens (Thriassio), resulting in the death of 57 passengers including train staff and at least 85 injured.

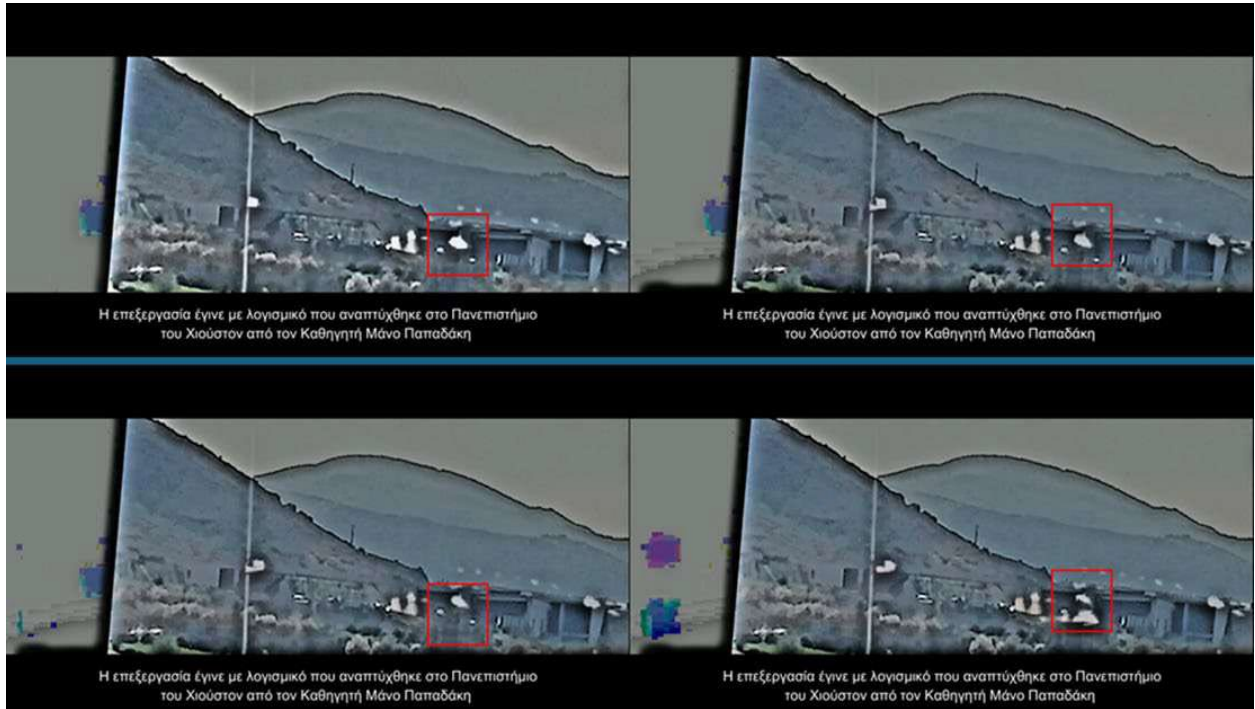
Immediately after the two locomotives veered off, a series of electric arcs were noticed. Those are also visible in one video clip (camera of Maliakos S.A.). Moments before the fireball started we also notice a cloud clearly rising over the accident site.

Figure 1. The rising vapor cloud shown in the red rectangles. On the bottom right panel there is fire below it (From Mr. Kokotsakis' report).

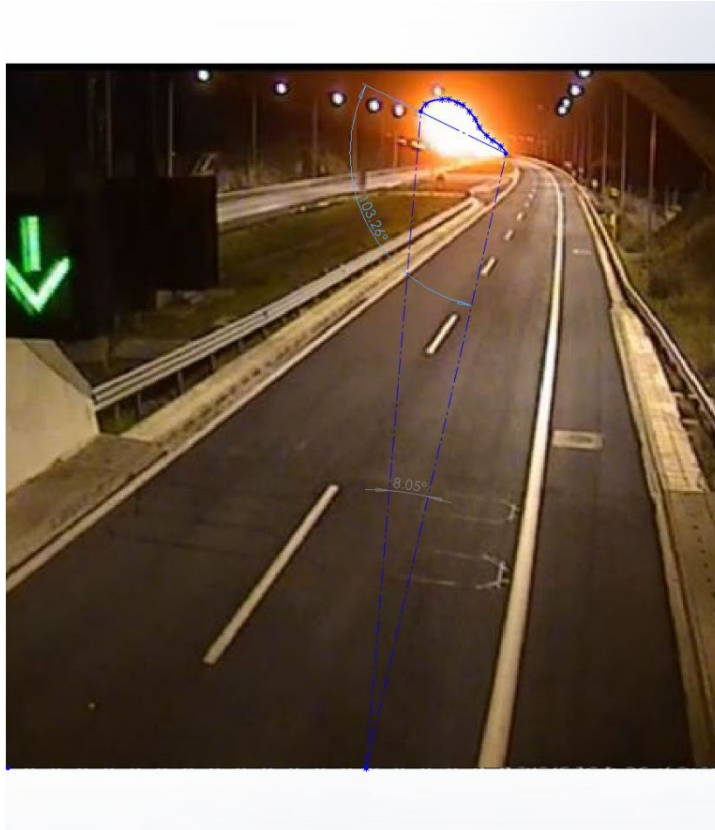
Then we have the development of the fireball. Using Solidworks we simulated the fireball. The simulation gave us its maximum volume to be 139987m^3 . The fireball was not isotropic. Its biggest dimension was 113m because it was elongated by the passing through it of the first car of the passenger train followed by the café car. This length has been estimated from a camera located at a tunnel viewing the fireball at approximately 103 degrees angle with its longitudinal plane (Fig. 2). These measurements are not ours but have been provided to us by Mr. Kokotsakis' team. Using SolidWorks, this team developed a 3D model of the fireball.

Figure 2. The triangle shows the calculation of the maximum length of the fireball. This is a frame extracted from one of the two videos in Exhibit A. The picture is extracted from Mr. Kokotsakis' report. The fireball maximum length as viewed from the Tempi 1 tunnel camera (located north of the accident site 750m away)

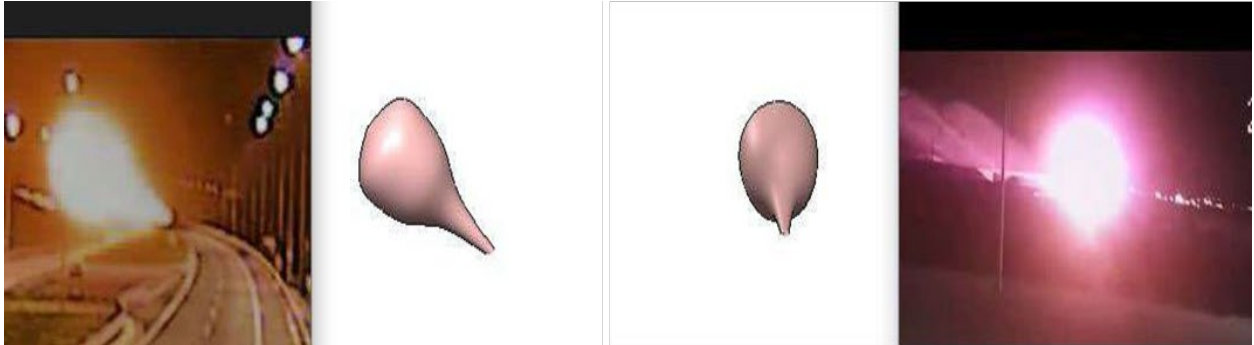
The SolidWorks simulation was cross correlated by Mr. Kokotsakis' team with the frames from the two videos listed in Exhibit A and was found to be in full agreement with its visual footprints in the videos (Fig. 3). The lifetime of the fireball was about 9.6 seconds.

Figure 3. Comparison of the simulated fireball views with actual footage. The left is from the camera at the Tempi 1 tunnel exit the right one is from the campus of Maliakos S.A. The scale in the actual images and the the simulation is 1:1. The simulated fireball has been adjusted for the distance and angle of view for each of the two cameras.
